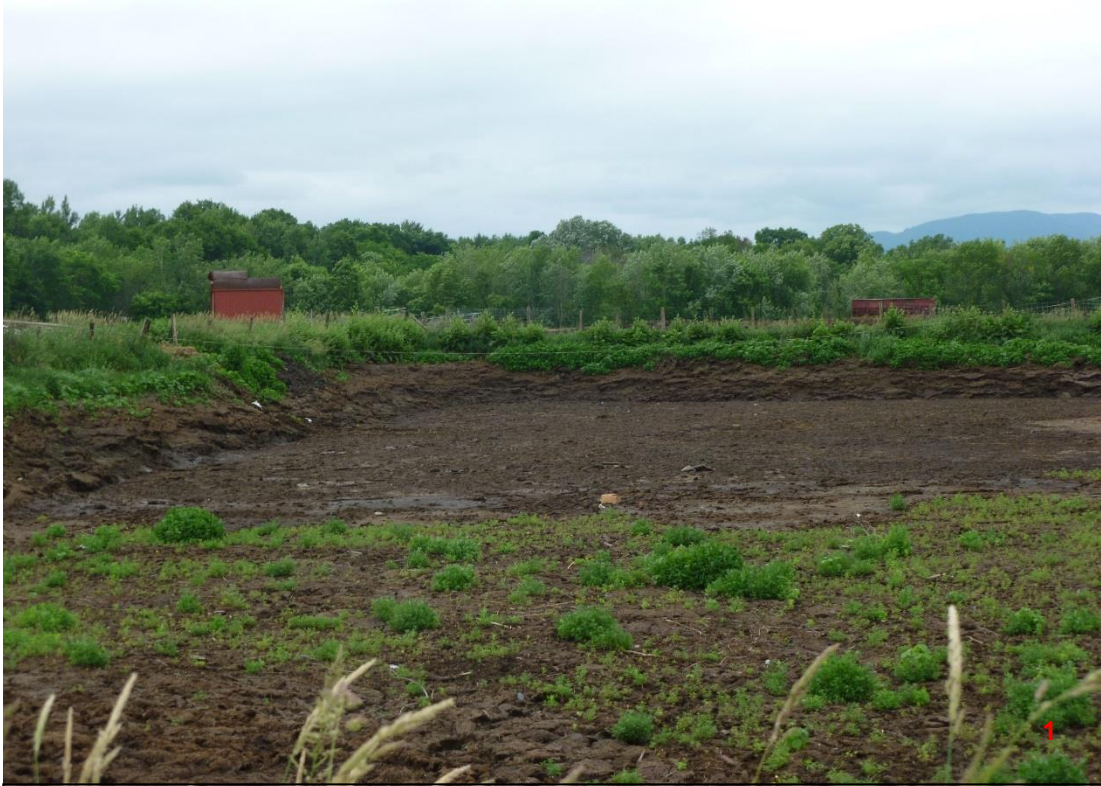
Picture 1 – Visser Brothers Farm, 2620 Panton Rd., New Haven, VT – 06/26/14
Manure pit at the main farm.

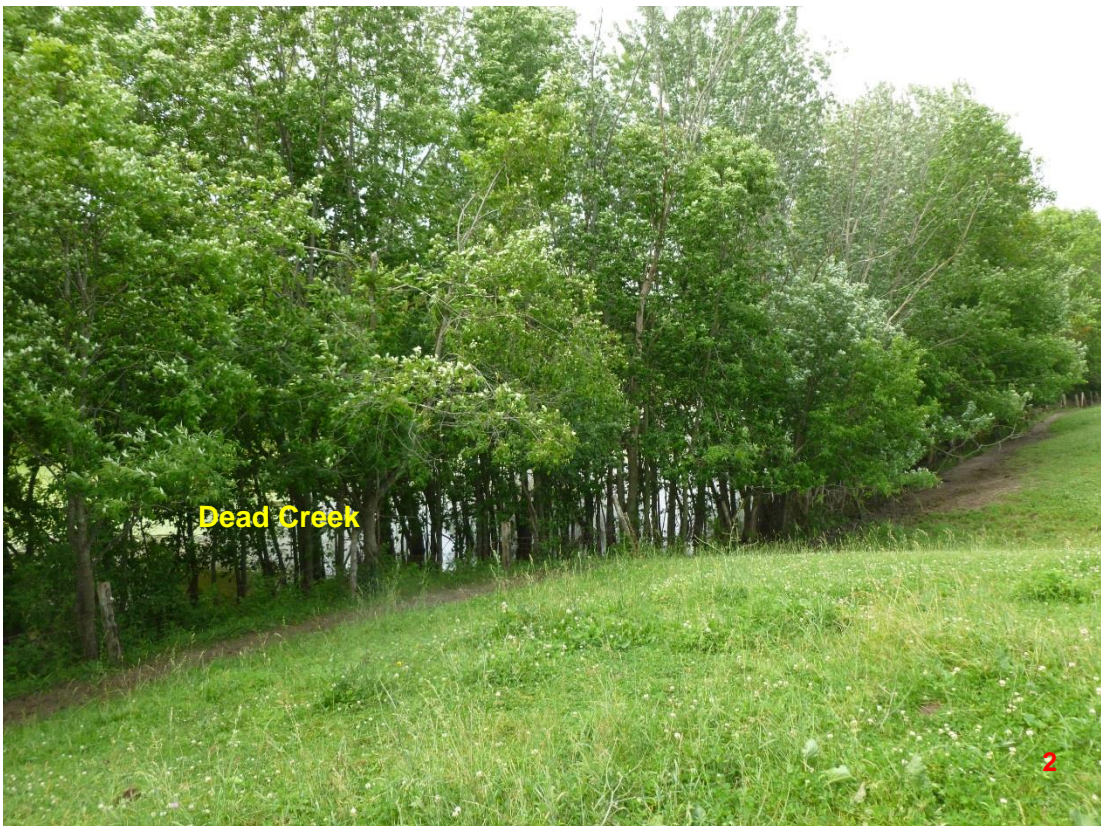
Picture 2 – Visser Brothers Farm, 2620 Panton Rd., New Haven, VT – 06/26/14
Extent of the heavy use area/pasture from the main farm to Dead Creek.

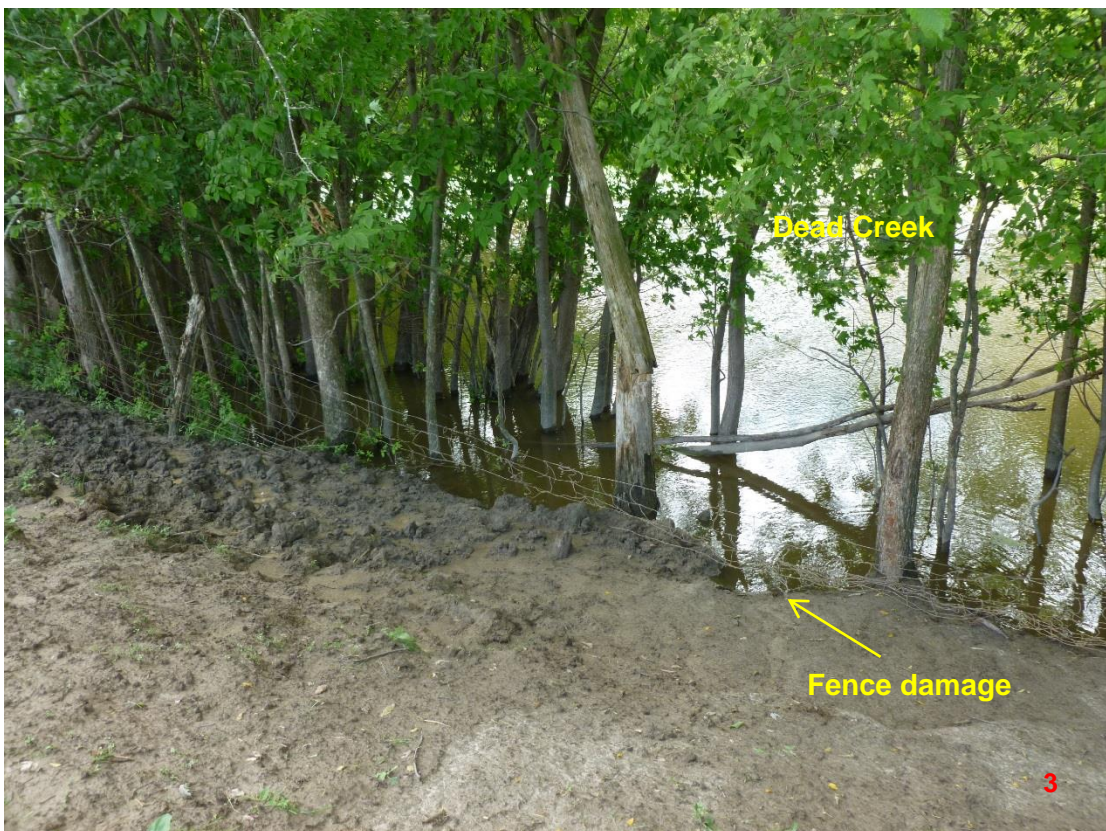
Picture 3 – Visser Brothers Farm, 2620 Pantan Rd., New Haven, VT – 06/26/14
Fence damage, bank erosion, and evidence of cow traffic at the edge of Dead Creek.

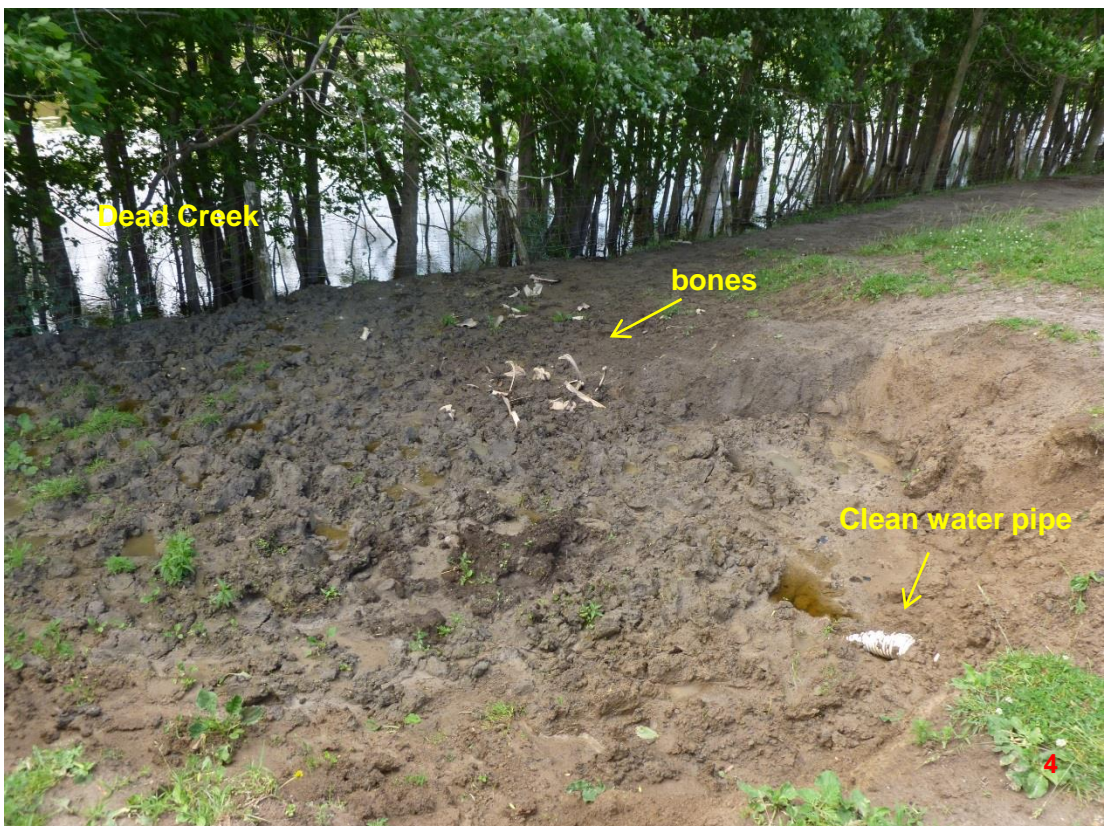
Picture 4 – Visser Brothers Farm, 2620 Pantan Rd., New Haven, VT – 06/26/14
Clean water diversion pipe discharge location, with cow hoof prints and bones in the area.

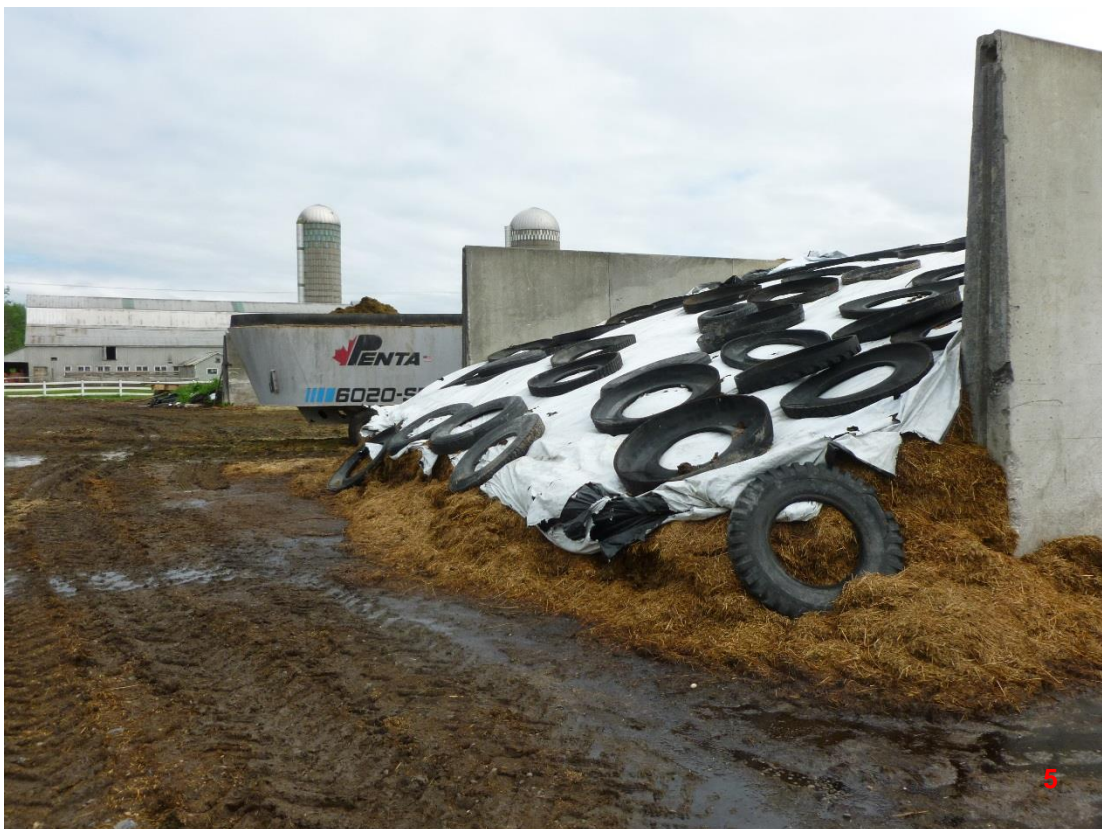
Picture 5 – Visser Brothers Farm, 2620 Pantan Rd., New Haven, VT – 06/26/14
West side of the silage bunkers (looking north toward the heifer farm).

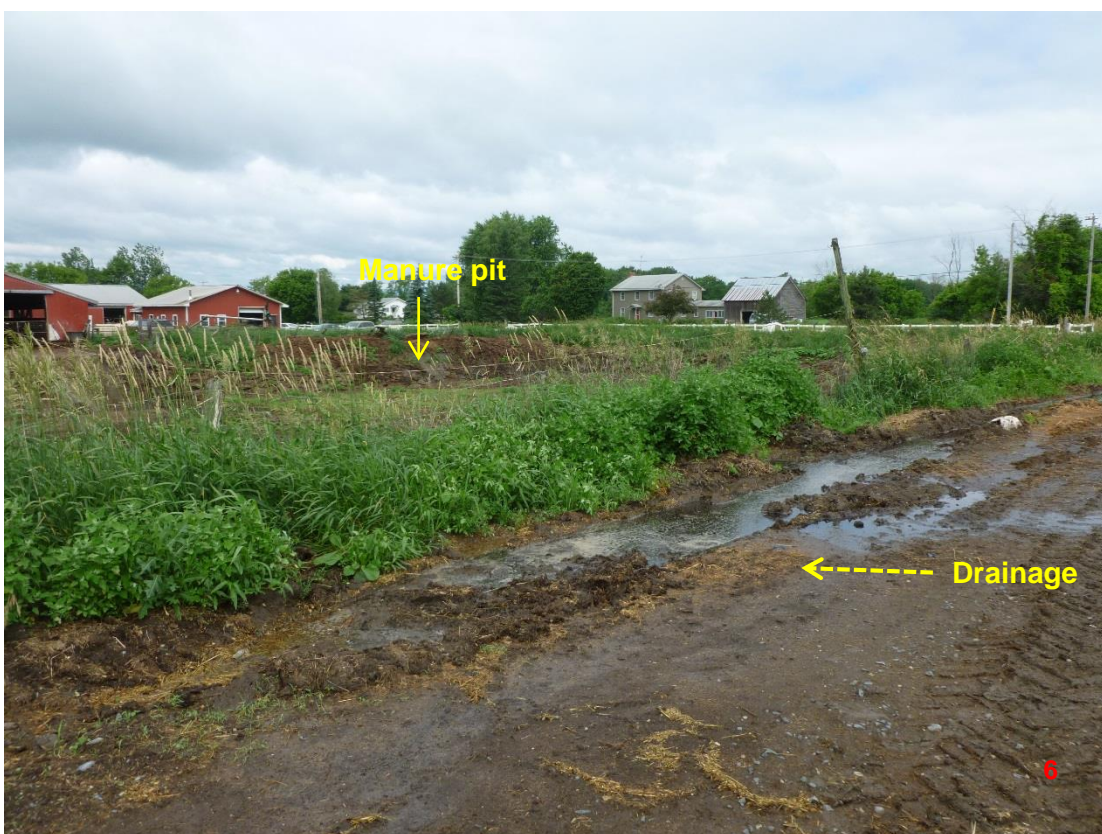
Picture 6 – Visser Brothers Farm, 2620 Pantan Rd., New Haven, VT – 06/26/14
Location where runoff from the west side of the silage bunkers enters the manure pit.

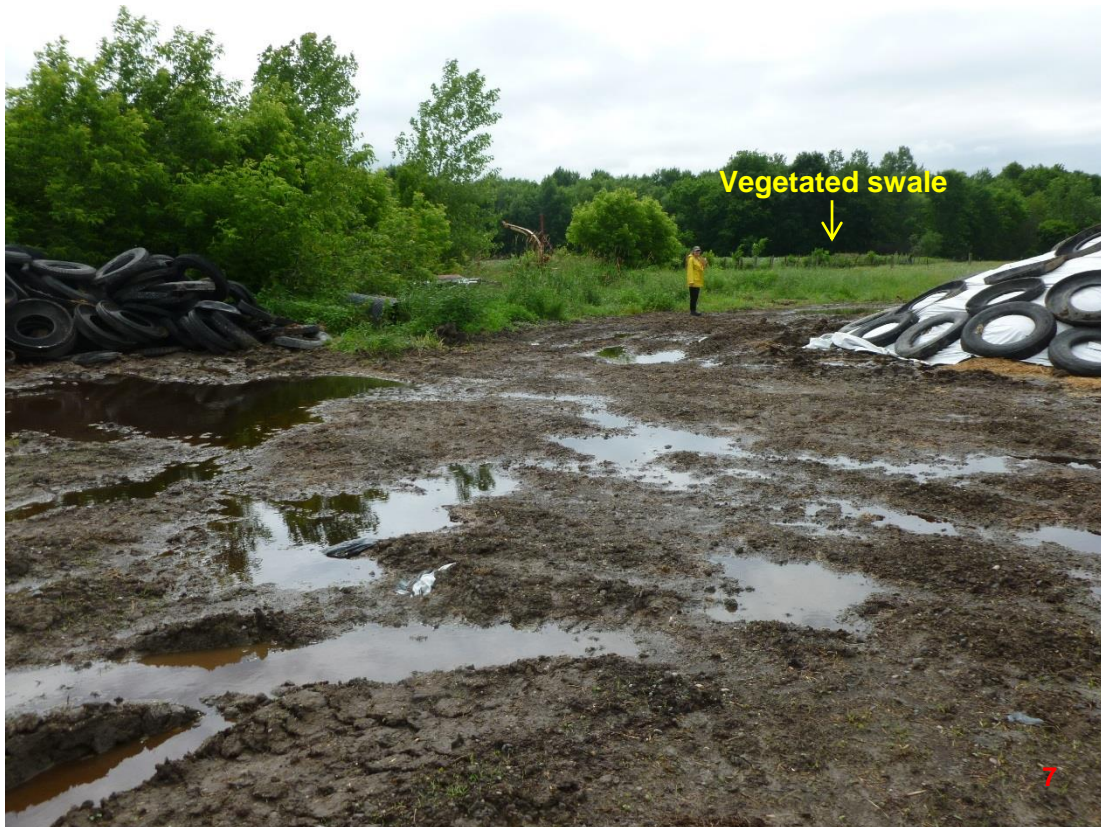
Picture 7 – Visser Brothers Farm, 2620 Pantan Rd., New Haven, VT – 06/26/14
Northeast side of the silage bunkers.

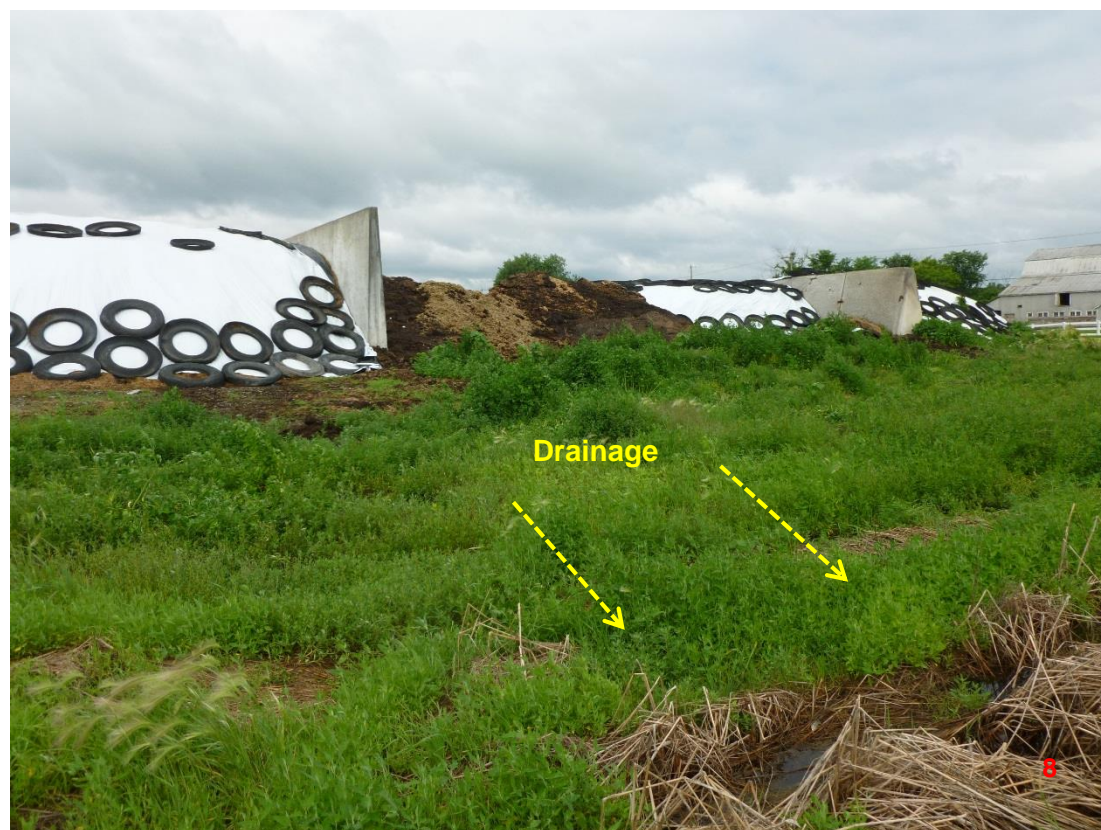
Picture 8 – Visser Brothers Farm, 2620 Pantan Rd., New Haven, VT – 06/26/14
Southeast side of the silage bunkers.

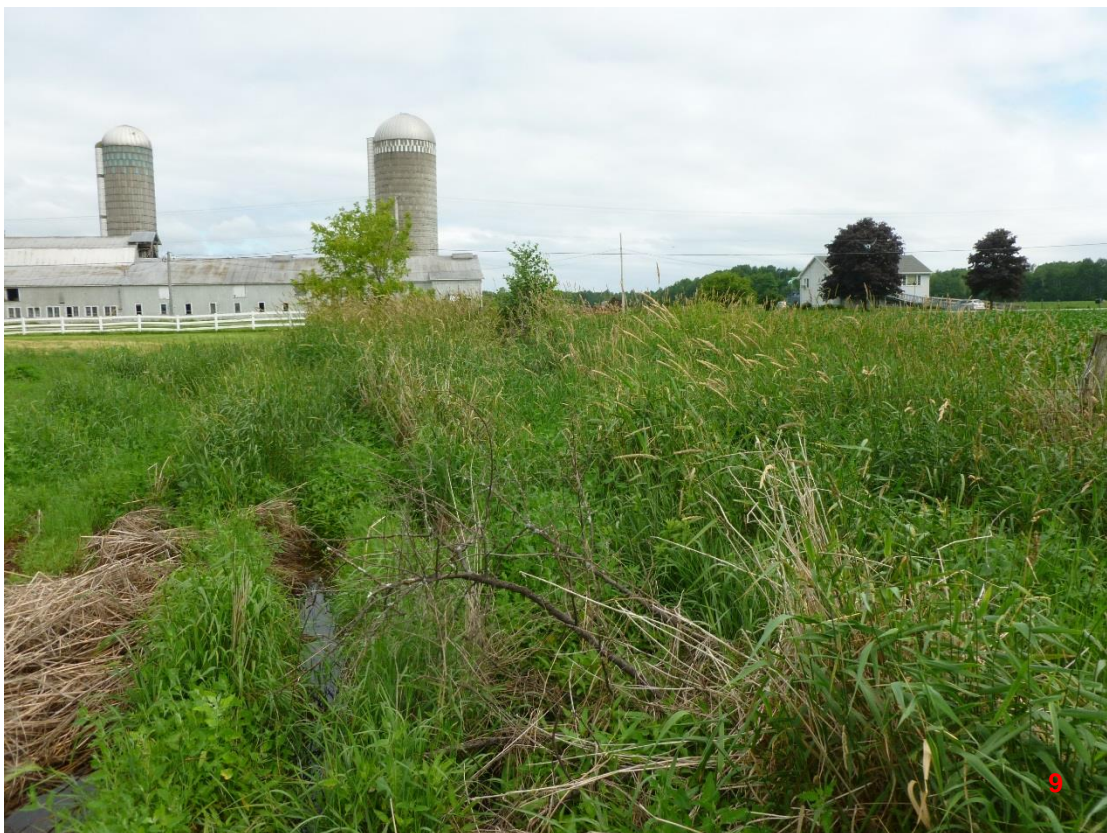
Picture 9 – Visser Brothers Farm, 2620 Panton Rd., New Haven, VT – 06/26/14
Vegetated drainage swale that receives runoff from the southeast side of the silage bunkers.

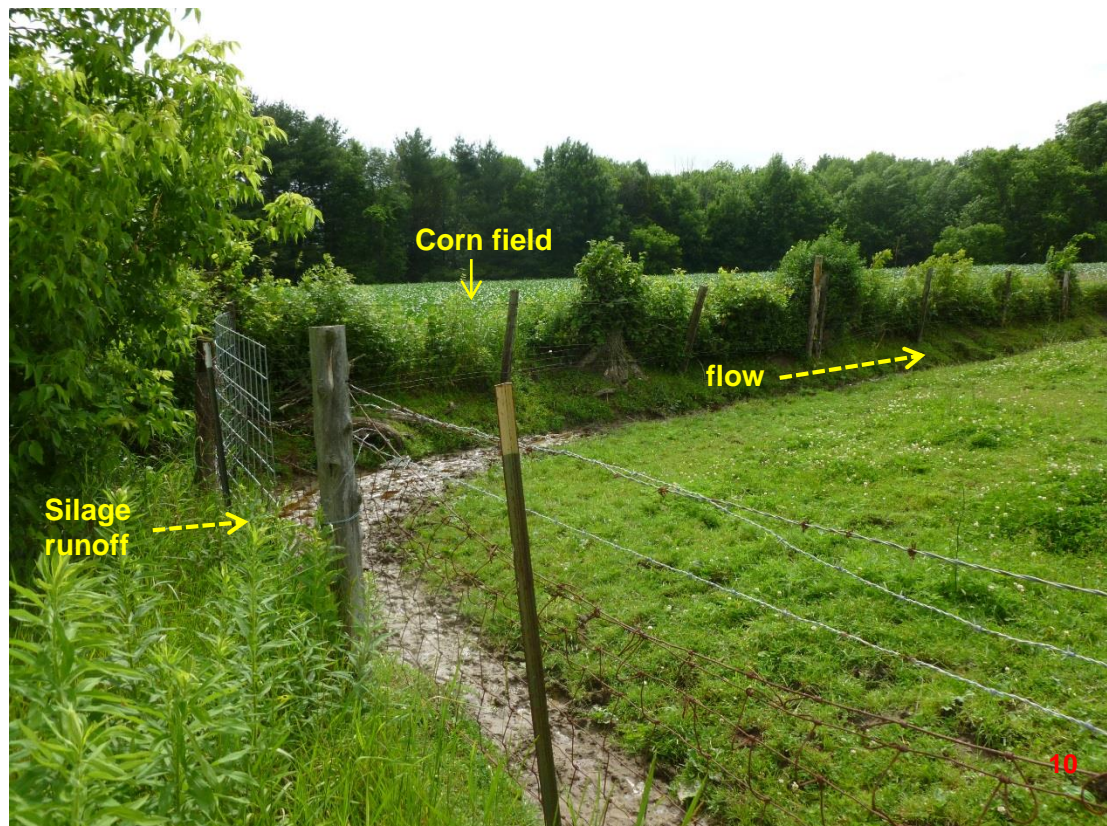
Picture 10 – Visser Brothers Farm, 2620 Panton Rd., New Haven, VT – 06/26/14
Location where silage runoff from the vegetated drainage swale enters a dirt ditch.

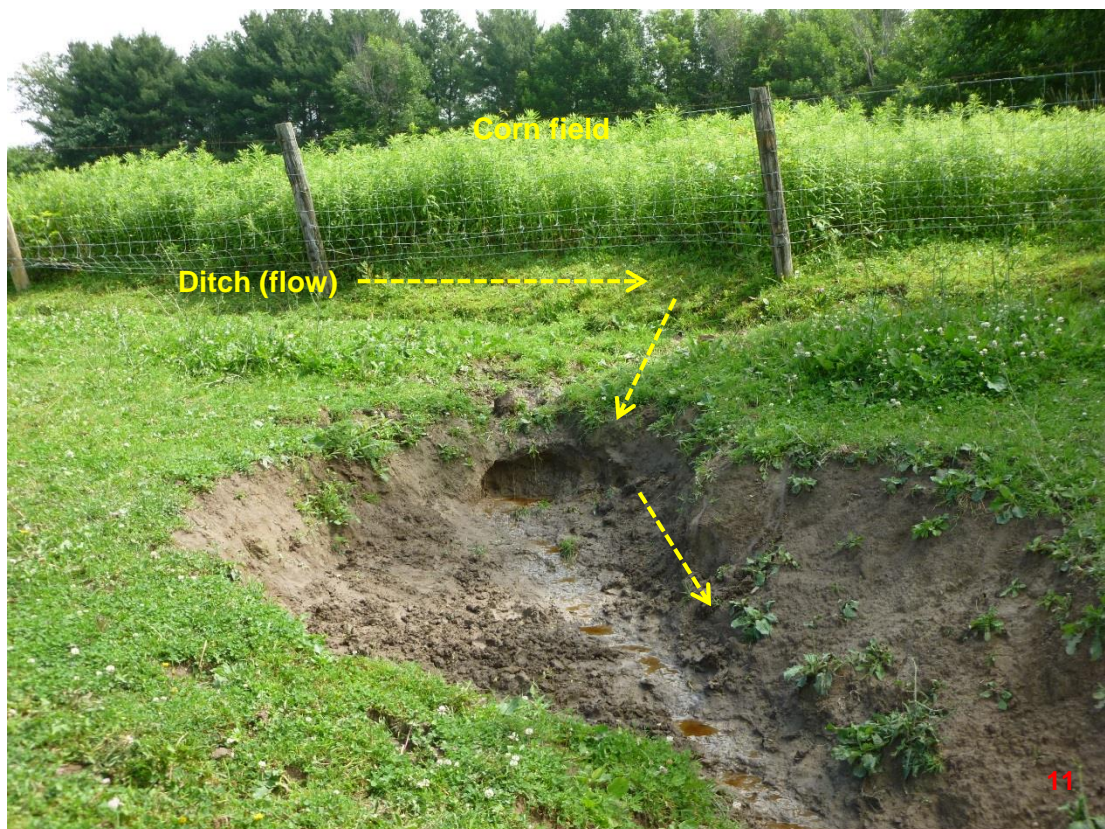
Picture 11 – Visser Brothers Farm, 2620 Pantan Rd., New Haven, VT – 06/26/14
Drainage ditch flowing south toward Dead Creek.

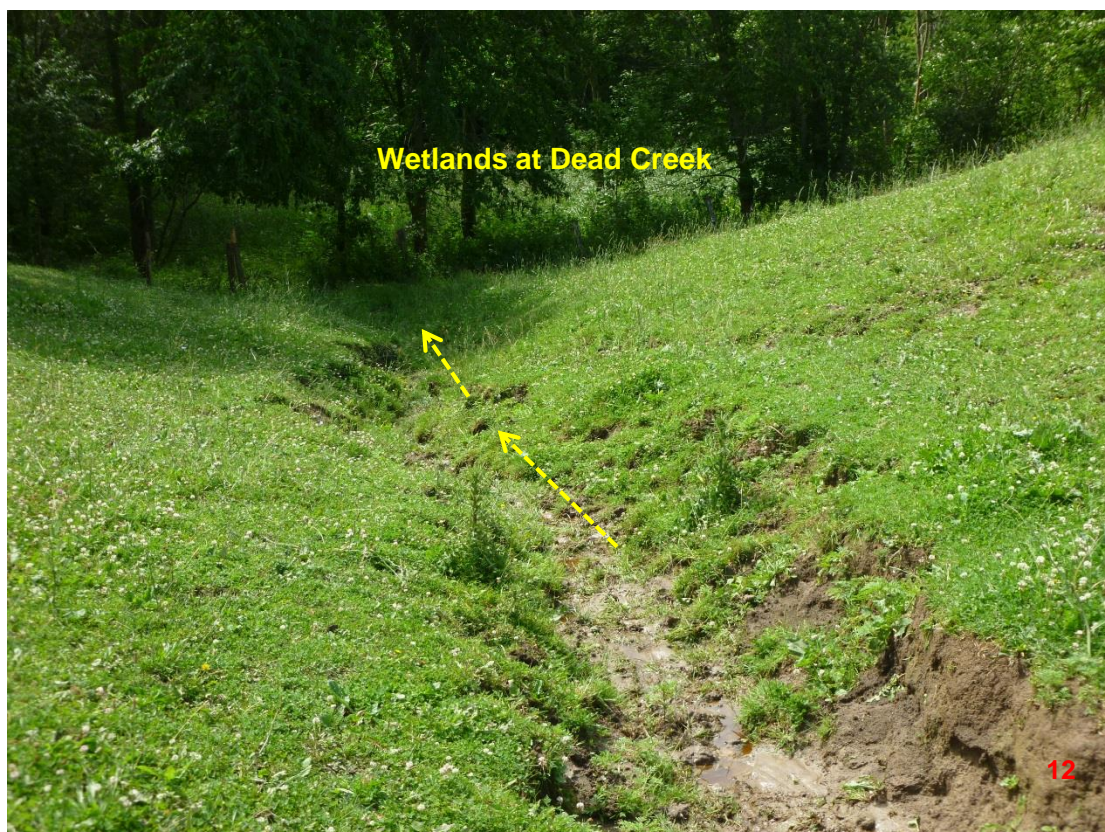
Picture 12 – Visser Brothers Farm, 2620 Pantan Rd., New Haven, VT – 06/26/14
Drainage ditch entering a wetland bordering Dead Creek.

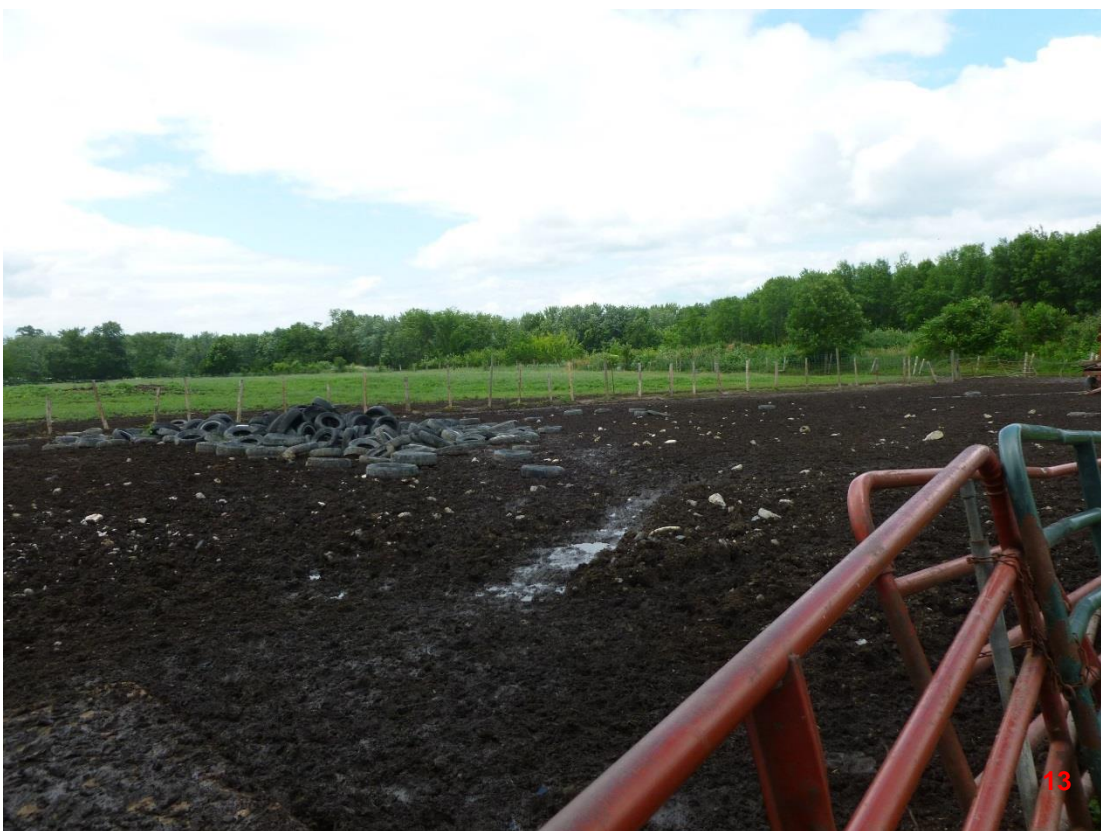
Picture 13 – Visser Brothers Farm, 2620 Panton Rd., New Haven, VT – 06/26/14
Heifer exercise lot at the main barn, located southwest of the barns.

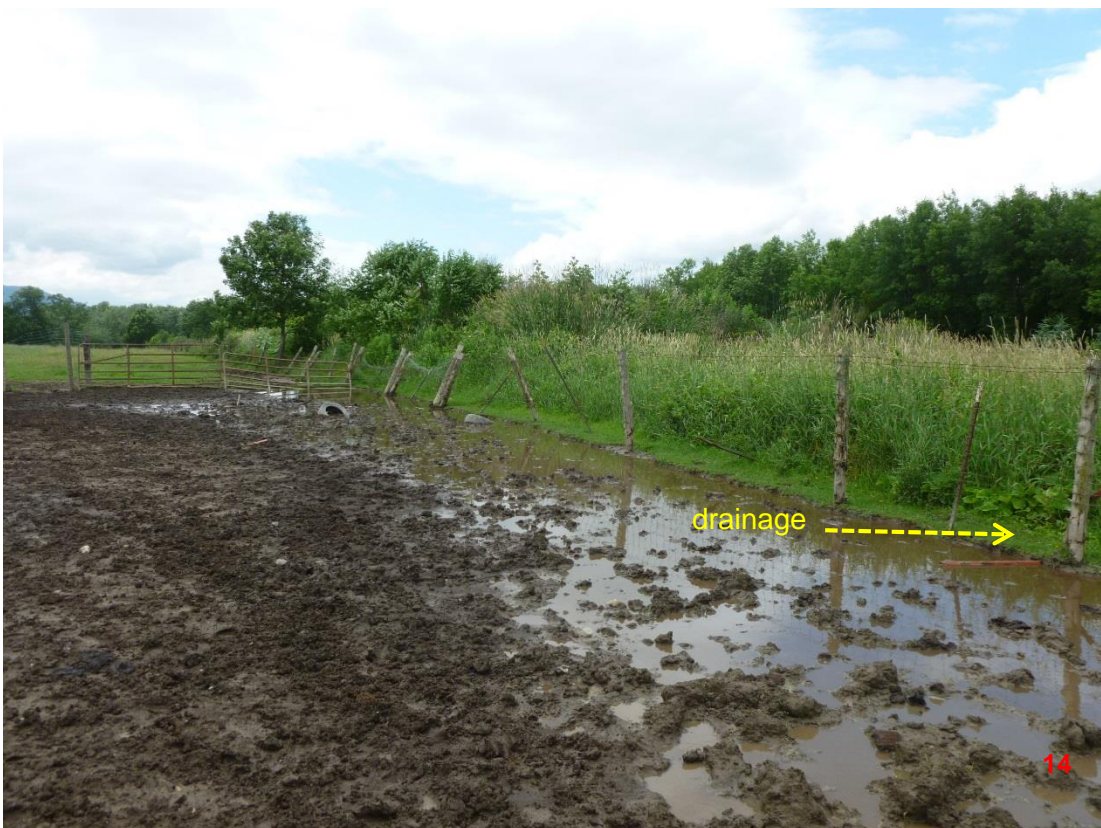
Picture 14 – Visser Brothers Farm, 2620 Panton Rd., New Haven, VT – 06/26/14
Water at the end of the exercise lot in picture #13.

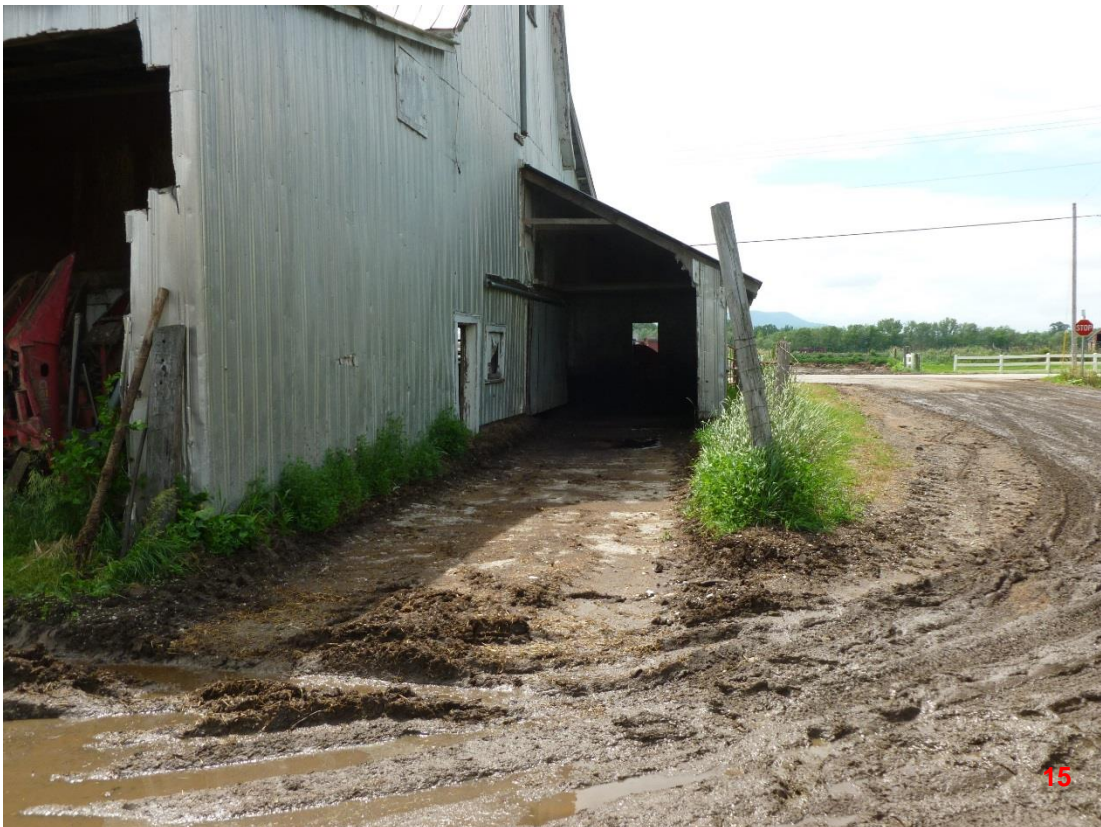
Picture 15 – Visser Brothers Farm, 2620 Pantan Rd., New Haven, VT – 06/26/14
Manure transfer area from the heifer barn on Stove Pipe City Rd.

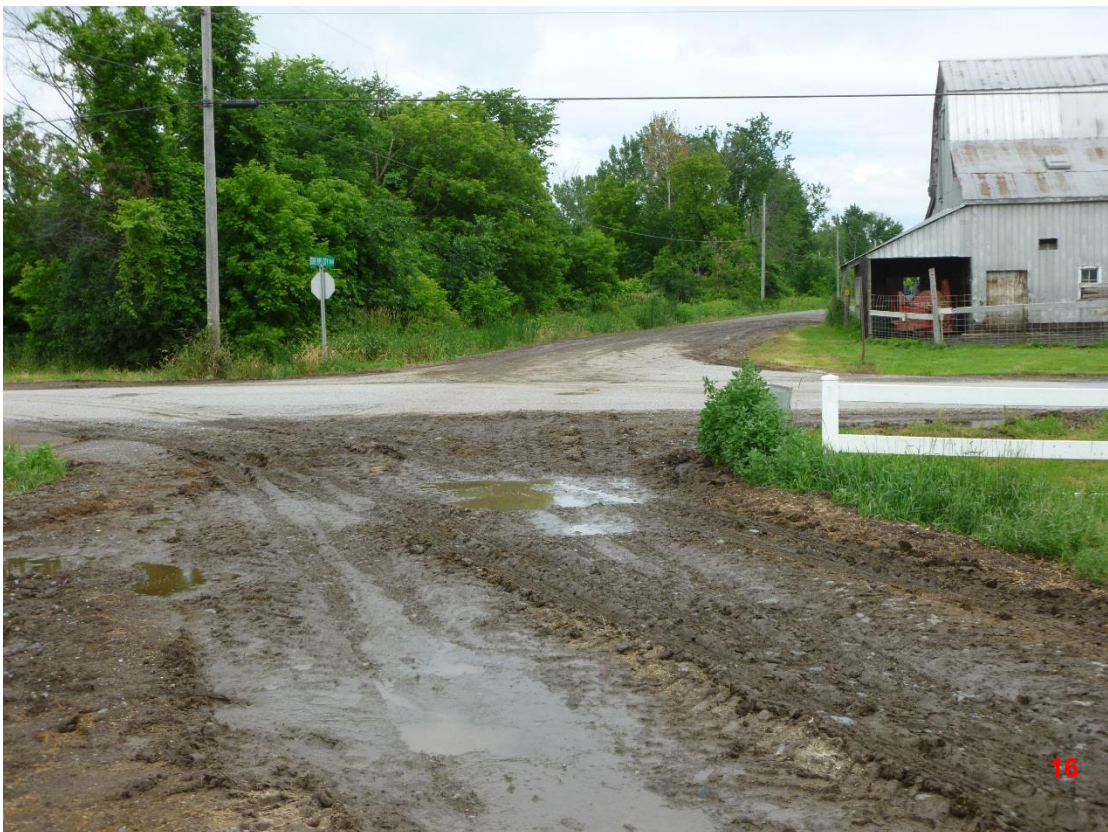
Picture 16 – Visser Brothers Farm, 2620 Pantan Rd., New Haven, VT – 06/26/14
Location where heifer barn manure is transferred across Pantan Road (looking north).

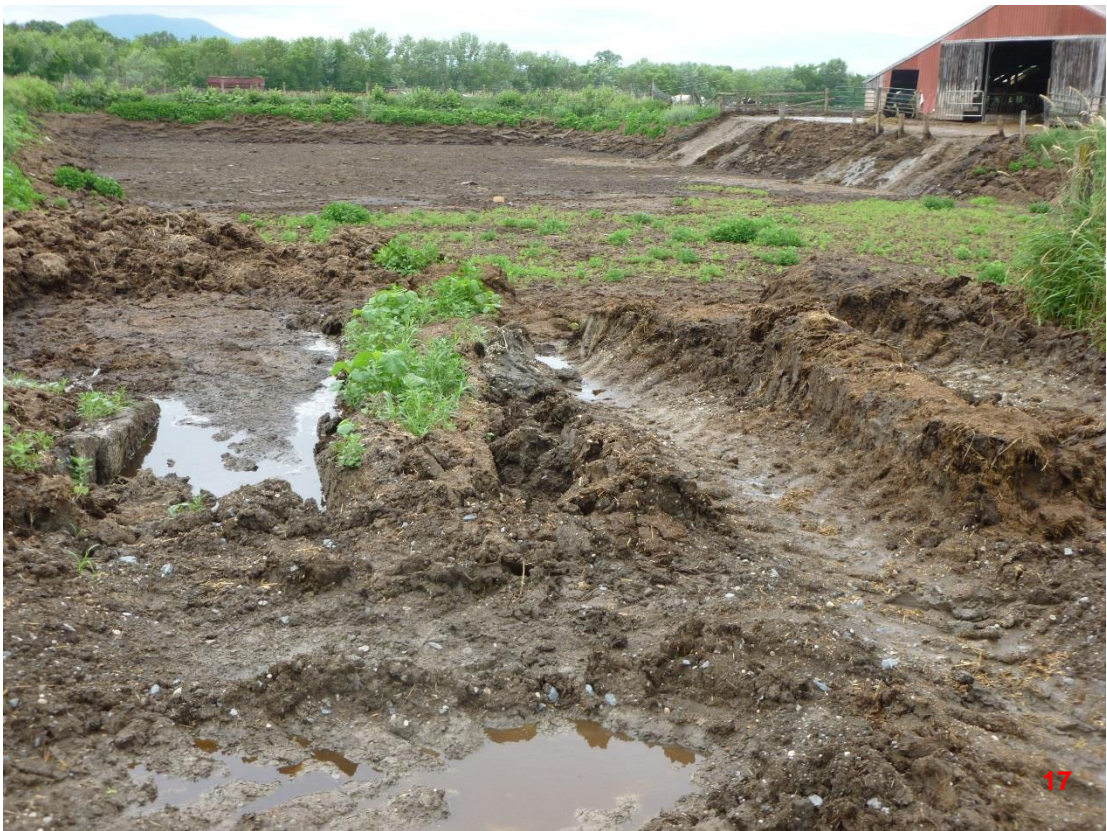
Picture 17 – Visser Brothers Farm, 2620 Pantan Rd., New Haven, VT – 06/26/14
Location where heifer barn manure is transferred into the manure pit (looking south).

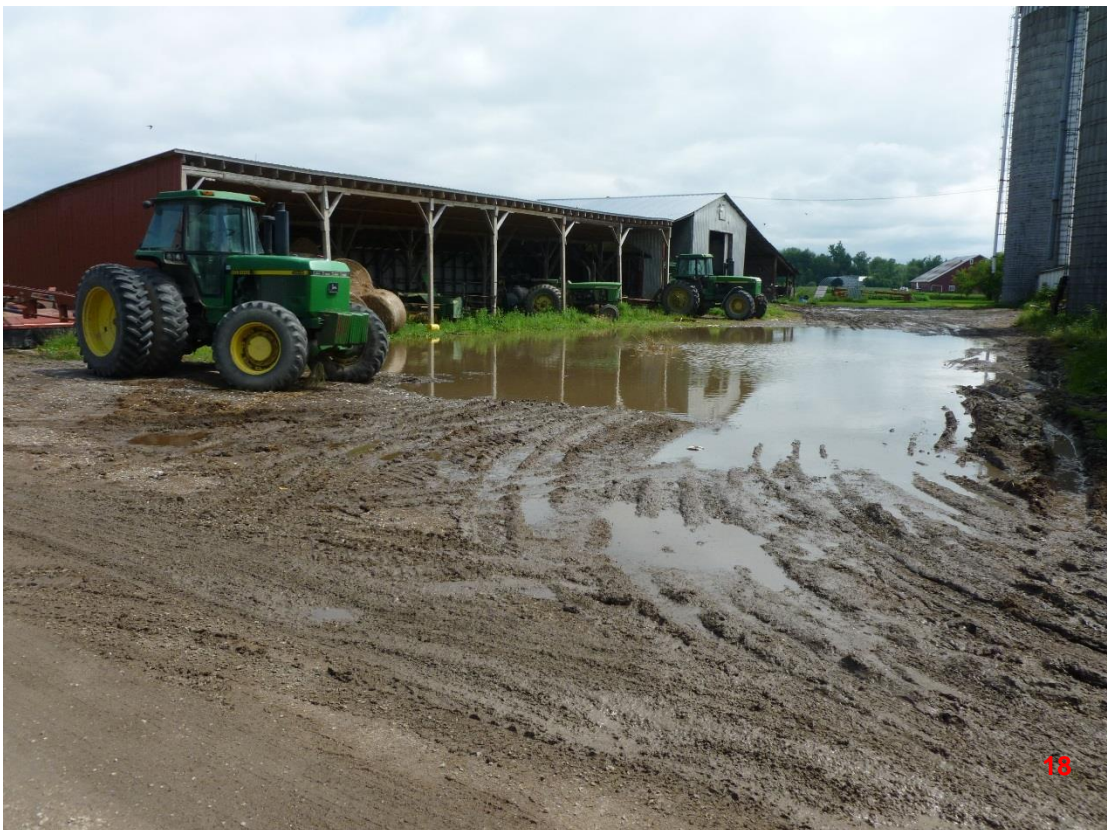
Picture 18 – Visser Brothers Farm, 2620 Pantan Rd., New Haven, VT – 06/26/14
Water pooling at the heifer farm on Stove Pipe City Rd.

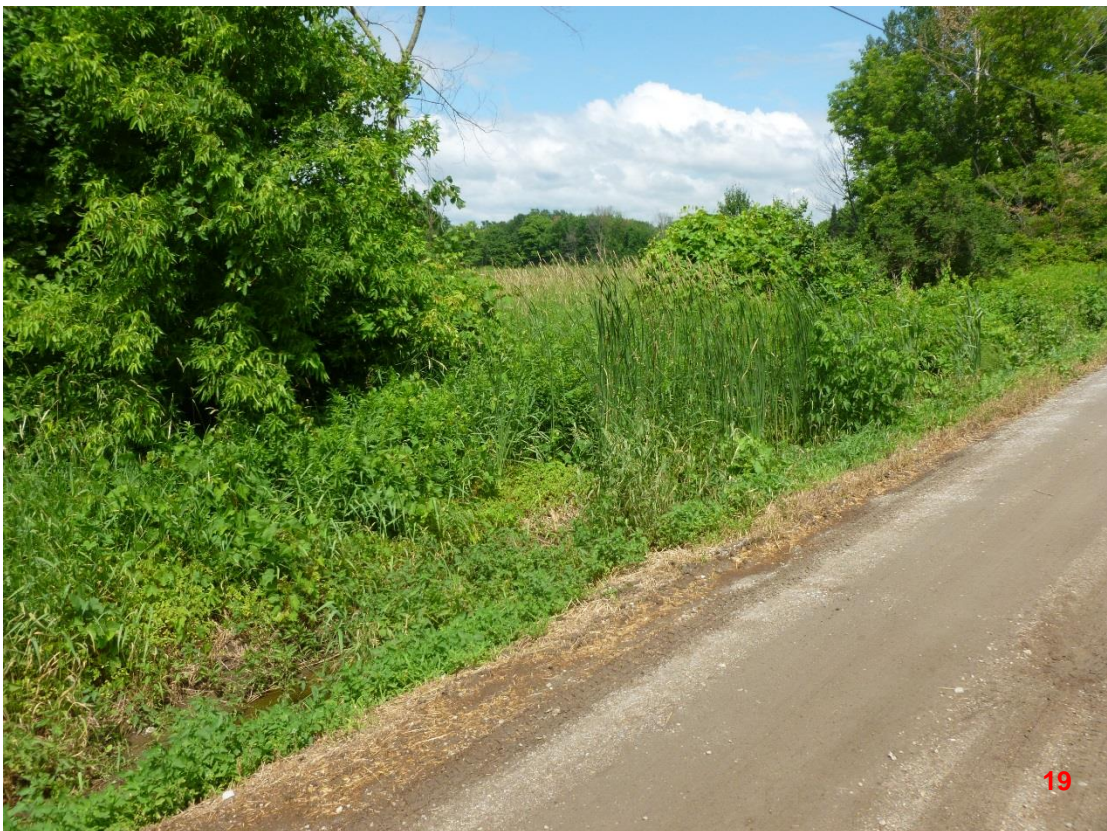
Picture 19 – Visser Brothers Farm, 2620 Panton Rd., New Haven, VT – 06/26/14
Roadside ditch on Stove Pipe City Rd. that receives runoff from the heifer farm.

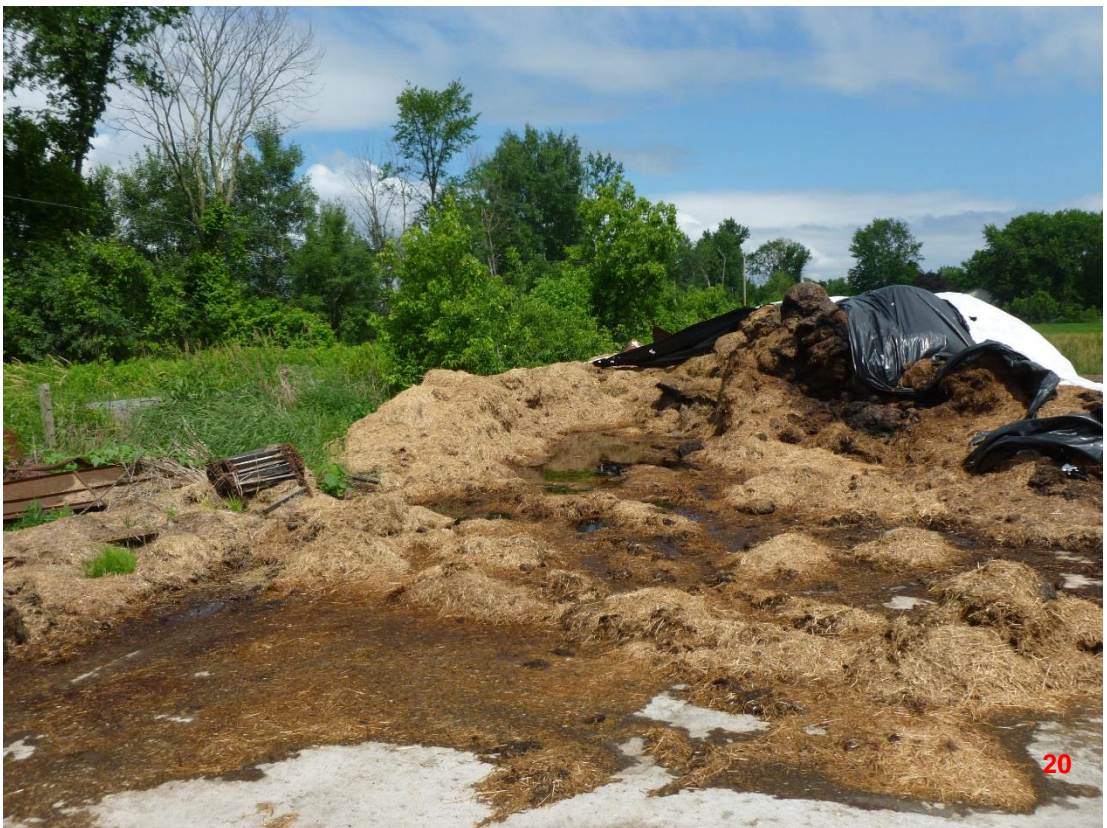
Picture 20 – Visser Brothers Farm, 2620 Panton Rd., New Haven, VT – 06/26/14
Bedding pile on a concrete pad at the heifer farm on Stove Pipe City Rd.
